Contract #: 04-0120F4Cty: SF/ALA Rte: 80 PM: 13.2/13.9File #: 69.28**WELDING INSPECTION REPORT****Resident Engineer:**Pursell, Gary**Address:** 333 Burma Road**City:** Oakland, CA 94607**Report No:** WIR-010471**Date Inspected:** 30-Dec-2009**Project Name:** SAS Superstructure**OSM Arrival Time:** 1900**Prime Contractor:** American Bridge/Fluor Enterprises, a JV**OSM Departure Time:** 700**Contractor:** Zhenhua Port Machinery Company, Ltd (ZPMC), Changxing Island **Location:** Shanghai, China**CWI Name:** Gong Liang Zhu**CWI Present:** Yes No**Inspected CWI report:** Yes No N/A**Rod Oven in Use:** Yes No N/A**Electrode to specification:** Yes No N/A**Weld Procedures Followed:** Yes No N/A**Qualified Welders:** Yes No N/A**Verified Joint Fit-up:** Yes No N/A**Approved Drawings:** Yes No N/A**Approved WPS:** Yes No N/A**Delayed / Cancelled:** Yes No N/A**Bridge No:** 34-0006**Component:** OBG/TOWER**Summary of Items Observed:**

**TRIAL ASSEMBLY YARD****ULTRASONIC INSPECTION****OBG SEGMENT 1AW -1BW**

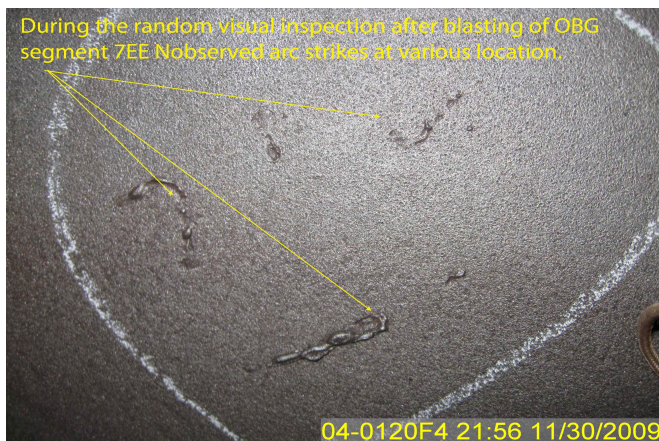
This Quality Assurance (QA) Inspector performed random visual inspection after blasting along with Caltrans Quality Assurance (QA) Inspector Mr. Daniel on inside bottom panel and side panel OBG segment 7DE. During the inspection we found normal minor gouges, arc strikes, spatter, undercut like discontinuities. For additional information see attached photo.
